CASE STUDY: CORRECTING MECHANICAL AND CONTROL PROBLEMS ON ESSROC'S MULTI-DRIVE STATION HORIZONTALLY CURVED CONVEYOR

Abstract

Essroc Cement's overland conveyor features three drive stations, transports material on both sides of the belt, and can discharge material at three locations. When originally commissioned, the conveyor was plagued by numerous mechanical and control related failures. This paper describes the mechanical and control modifications that were required to make this conveyor reliable.

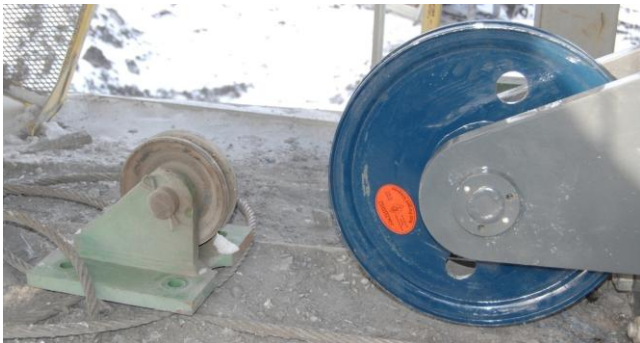
- 6-inch diameter sheaves were used to guide the 6x37, 3/4" diameter wire rope from the counterweight to the take-up trolley. The minimum sheave diameter required for this type of cable is 18 times the diameter

of the wire rope (Shigley), or about 333% larger than the sheaves that were installed (Figure 5).

Figure 5: Old 6" sheave lying next to the new 20" sheave that replaced it.

CDI recommended increasing the diameter of the sheaves to 20". Essroc accepted and, in the spring of 2009, CDI returned to the site to record the behavior of the belt before and after installing the new sheaves. Testing showed that the old sheaves were indeed preventing the take-up from moving, therefore allowing large variations of belt tension. Installing new sheaves with a larger diameter freed the counterweight to move and reduced these variations. However, the motor torque recordings taken during this trip showed that the drive control algorithms implemented by the PLC manufacturer were also inadequate and created large tension fluctuations in the belt.

Following the delivery of the new, larger sheaves (Figure 5), CDI visited Essroc to record the behavior of the belt before and after installation of the new sheaves. A number of instruments, including: strain gauges, load cells, and tachometers were installed, and several starting and stopping tests, under various loading conditions, were conducted to determine how the belt performance changed after the sheave replacement.

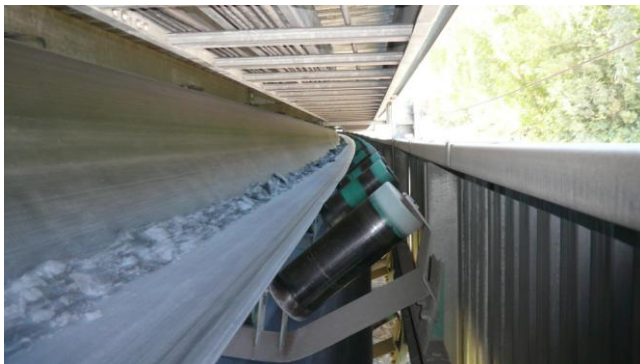
- The belt side-travel in the horizontally curved sections of the conveyor was grossly excessive. There was a large amount of spilled material in these curved sections, and the edge of the belt was extensively damaged (no side-guide rollers are used in the system, Figure 6).

Figure 6: Large side travel in unloaded 400m horizontal curve

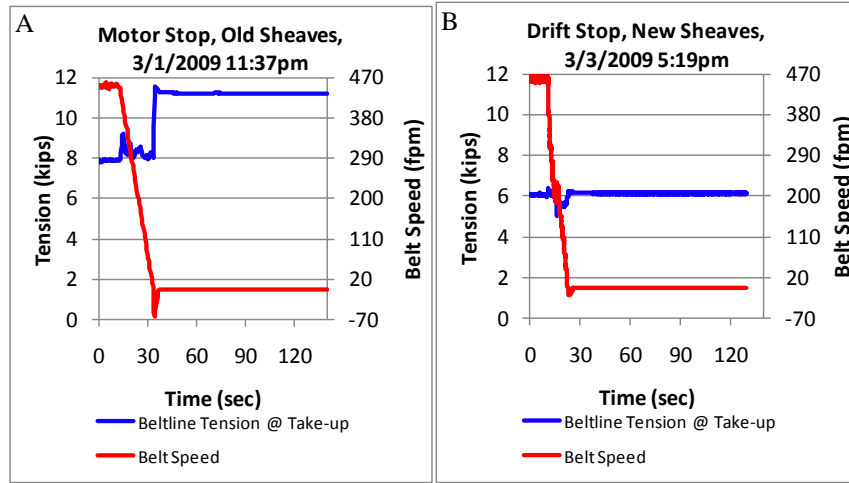
The first series of tests were conducted with the old, small, sheaves. Figure 7 shows that, with the old sheaves installed, the belt tension at the take-up pulley increased to nearly 12000 lbs (twice its nominal value) after the motors were tripped at the end of a loaded motor-stop test. This clearly shows that the small sheaves prevented the take-up from moving up. 20 minutes later, the tension still had not returned to its normal levels of 6000 lbs. When the conveyor was started again, the tension first dropped to 6000 lbs (Figure 8a), but soon increased again to 8000 lbs as the loading of the conveyor changed. The belt tension at the take-up pulley was then recorded during 25 minutes of continuous operation. This test showed the belt tension continuously changing according to the average load on the conveyor, and sometimes dropping substantially below 6000 lbs (Figure 9a).

Figure 7: Belt tension on the take-up pulley during a conveyor stop before and after the new sheaves were installed.

The same tests were conducted after the new sheaves were installed. The new sheaves greatly reduced the variation in belt tension at the take-up trolley (Figure 7b, Figure 8b, and Figure 9b). This significantly reduced the likelihood of tension related failures.

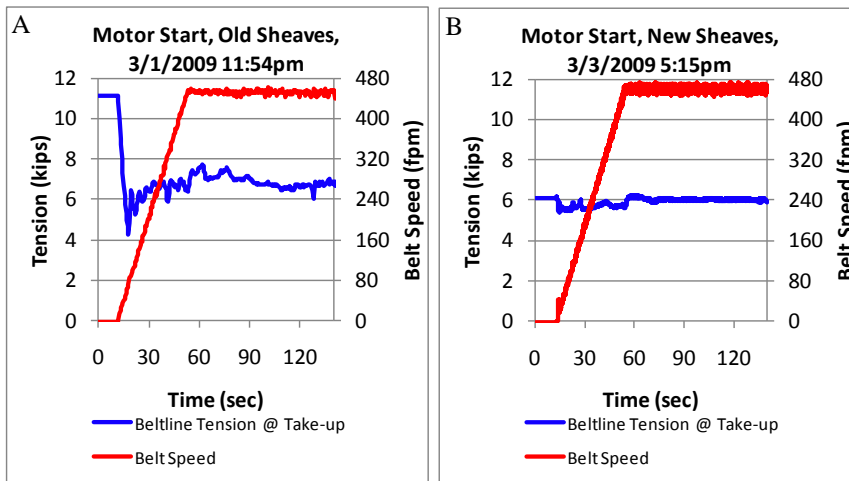
Figure 8: Belt tension on the take-up pulley during a conveyor start before and after the new sheaves were installed.

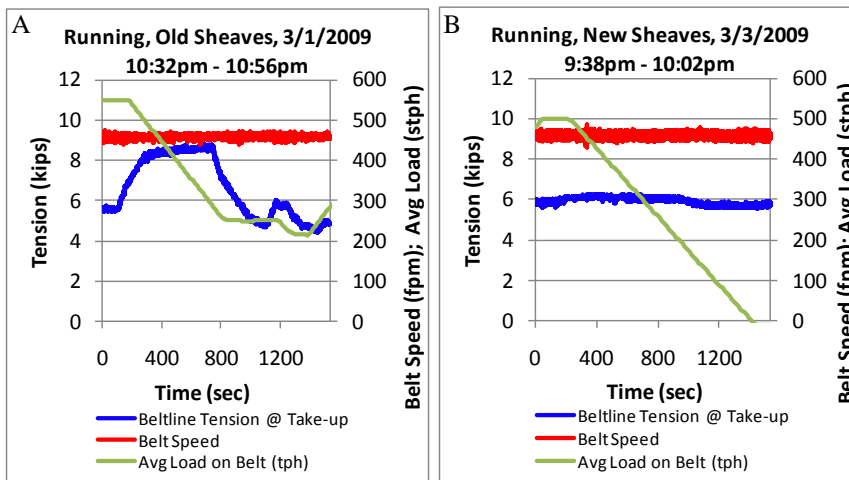
Figure 9: Belt tension on the take-up pulley during normal operation before and after the new sheaves were installed.

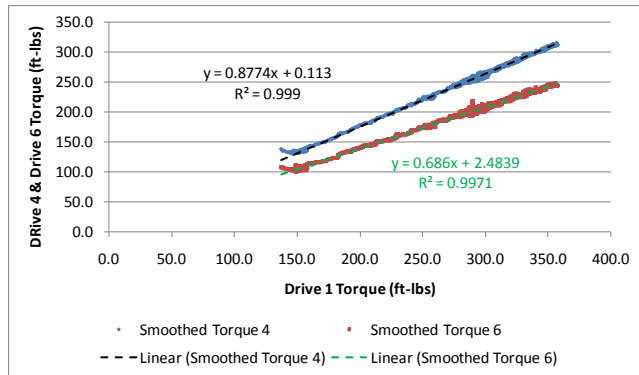
During the tests conducted on site in the spring of 2009, all six motor torques were recorded. Figure 10 shows the head drives torque plotted against the carry-side booster drives torque and the return-side booster drive torque under running conditions (excluding starting and stopping) for all the loading conditions that were observed during the three days of testing. The drive torque at each drive station was clearly controlled to maintain a constant load-sharing ratio between the head and the two booster stations, *independently of the conveyor loading or of the location of the material on the belt.*

Consequently, while the motors' torques were shared reasonably well when the conveyor was loaded over its complete length, this control scheme created unnecessarily large tensions in empty sections of belt as the material moved through the belt (during conveyor loading and unloading). This resulted in large, and damaging, levels of side travel in horizontally curved sections (Figure 11.). The damages to the edges of the belt were made worse by the absence of any side-guide rollers in the horizontally curved sections of the conveyor.

Figure 10: Distribution of motor torque created by the original *Essroc* control system during normal operation. Drives 1, 2, and 3 have equal torque (head drives), Drives 4 and 5 also have equal torque (carry-side booster drives), and Drive 6 is the return-side booster.

CDI's approach to controlling such a conveyor, and to booster-stations control in general, is to independently control the drive torque at each station. Each drive station should only provide the torque required to pull the portion of the belt and material directly upstream of its location, and all drive stations should act independently of one another except during starting and stopping sequences (Ref 3).

The best way to achieve this decoupling between drive stations is to control the head drives with a normal speed-control loop, but to control the booster drives with tension-control loops using load cells to measure the belt tension on the downstream side of the booster stations. This method effectively creates "virtual" take-up after each booster station, decoupling them from each other's and from the head drive station.

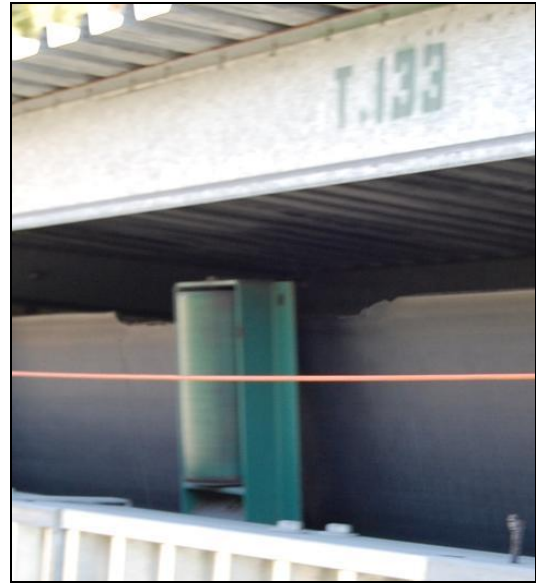
Figure 12 shows the tension distribution when limestone is loaded on the belt between the tail and the carry-side booster station, and clinker is loaded on the return side of the belt. Note that under this loading condition, the belt is empty between the carry-side booster station and the head. Under the old control scheme, the head drives still delivered the bulk of the required torque, even though the belt was empty between the carry-side booster and the head. This effectively raised the belt tension in all the horizontal curves near the carry-side booster station, causing excessive side travel of the empty belt in these sections. Without side-guide rollers, the high belt tensions lifted the belt all the way into the structure, which resulted in extensive damage to the edges of the belt (Figure 11).

Figure 11: Edge damage caused by excessive side travel in horizontal curves.

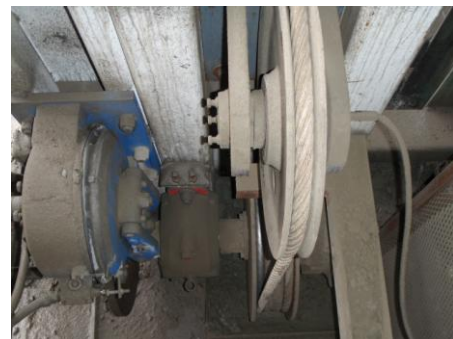
Figure 14: Capstan Take-up Brake

Part of the solution applied by CDI was to install a capstan brake on the take-up (Figure 14). A capstan brake is installed on the take-up sheaves assembly and, when applied, increases the take-up resistance to motion, therefore increasing the effective take-up tension. In this

case, a spring-applied, electrically-released brake was selected to insure application in case of power failure. The capstan brake is kept released at all time during operation, and only applies in case of motor trip or power failure.

- CDI recommended installing a capstan brake on the take-up to increase the tension in the tail turnover area during emergency stop (motor trips, power loss, etc.). This type of brake is inserted between take-up sheaves and, when applied, increases the take-up resistance to motion, therefore increasing the effective take-up

tension. The brake is released during normal operation and only applies during emergency stops. Following this recommendation, Essroc commissioned CDI to design and supply a capstan brake that fits in CV-105's current take-up trolley gallery. CDI sourced the frame and capstan from RAS Pulley, and the brake caliper from Johnson Industries, then shipped the final assembly to Essroc.

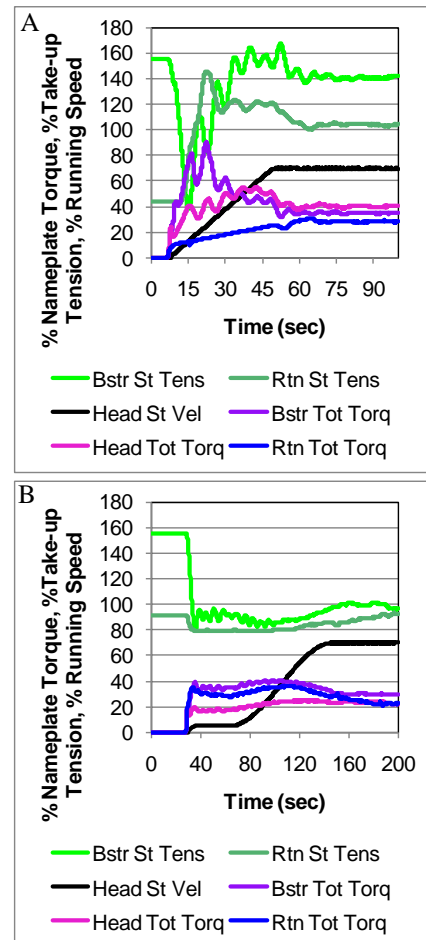
Figure 16 shows the response of the conveyor during a start using the original control and the CDI control. The original control scheme generated large fluctuations in motor torque and huge swings in belt tension (both high and low). The belt tensions are nearly constant and the motor

torques are far more stable with the new CDI control scheme.

Figure 16: Recorded motor torques and belt tensions after the booster drives (at the load cells locations) during a conveyor start fully loaded before (A) and after (B) installation of the new CDI drive controls.

Tests performed on site before and after installation of the new CDI control system confirmed this result. The following recordings show the motor torque at each drive station and the belt tension after each booster drive during fully loaded conveyor starts and motor-stops. The belt tension was recorded by two load cells mounted under two pulleys located on the low-tension side of the drives.

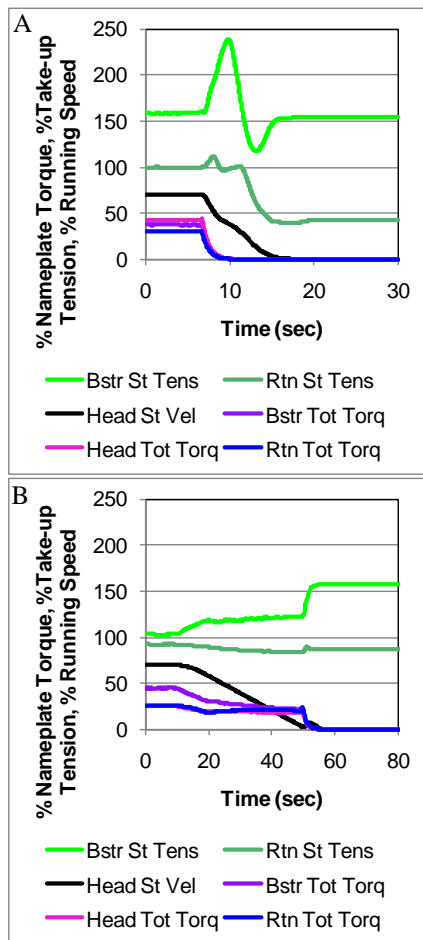
Figure 17 shows the response of the conveyor during a motor-stop using the original control and the CDI control. Again, the original control scheme generated large fluctuations in belt tension (both high and low). No large tension swings were observed with the new CDI control scheme.

Figure 17: Recorded motor torques and belt tensions after the booster drives (at the load cells locations) during a motor stop fully loaded before (A) and after (B) installation of the new CDI drive controls.
