FLEXCO ELEVATE™ AND CONVEYOR MONITORING

Flexco Elevate™ is a real-time, remote monitoring solution that leverages the power of action-oriented insights to bring transparency and predictability to your operation.

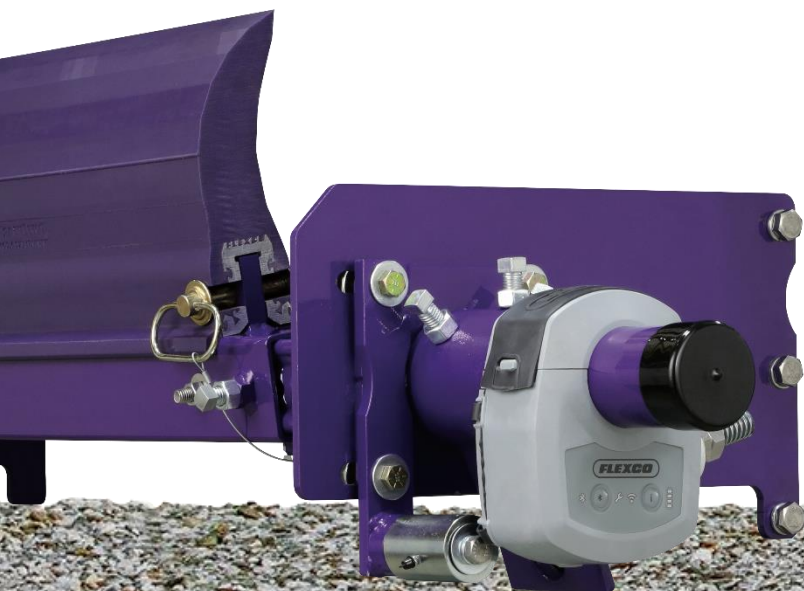
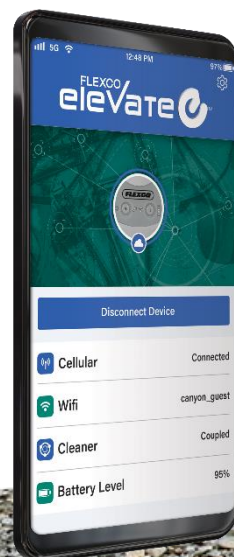
i3 DEVICE

- Sensor, communication & power in a single unit—no need for additional equipment

i3 MOBILE APP

- Create digital service records

i3 DASHBOARD

- Remotely monitor real-time insights

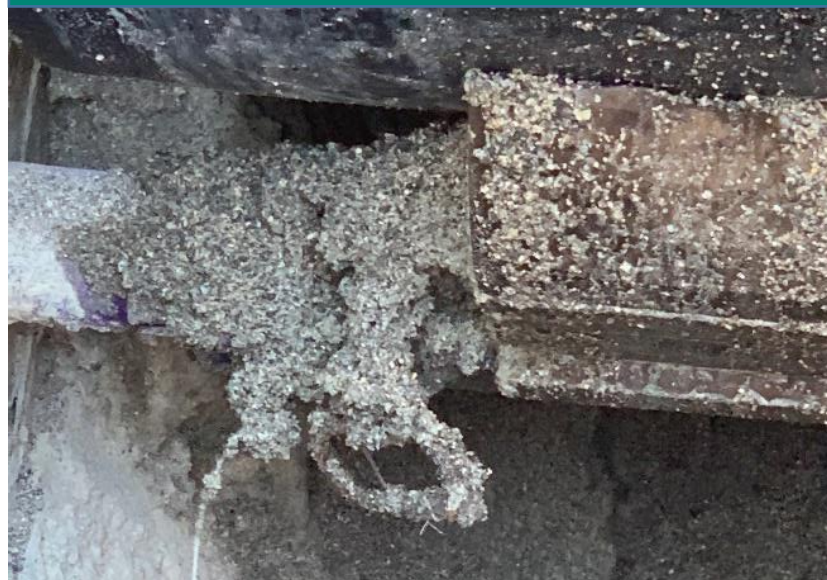
ON-SITE INVESTIGATION

A cleaner pin came loose and the MMP blade traversed to the edge of the belt, eventually contacting the pulley lagging.

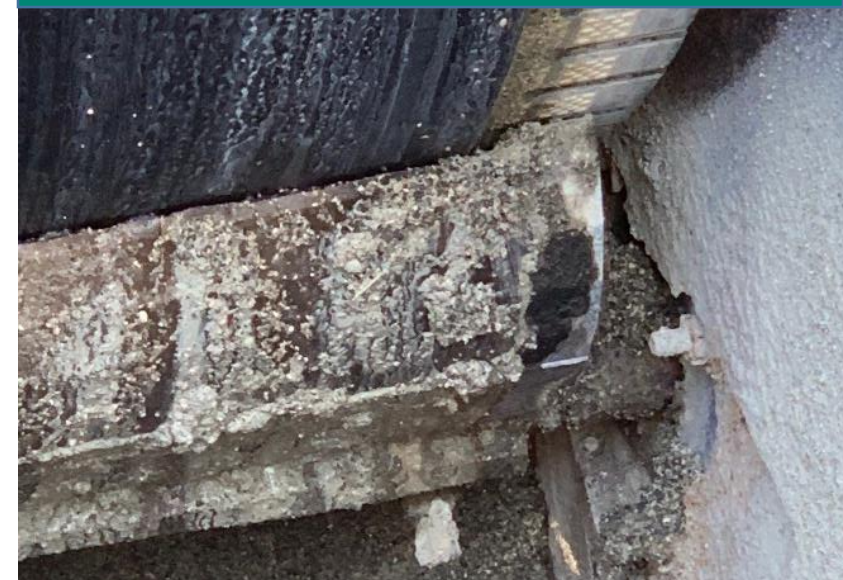
DIGITAL, PHYSICAL CONNECTION

The unlocked / unsupported blade caused the abnormal vibrations which triggered action before further damage occurred.

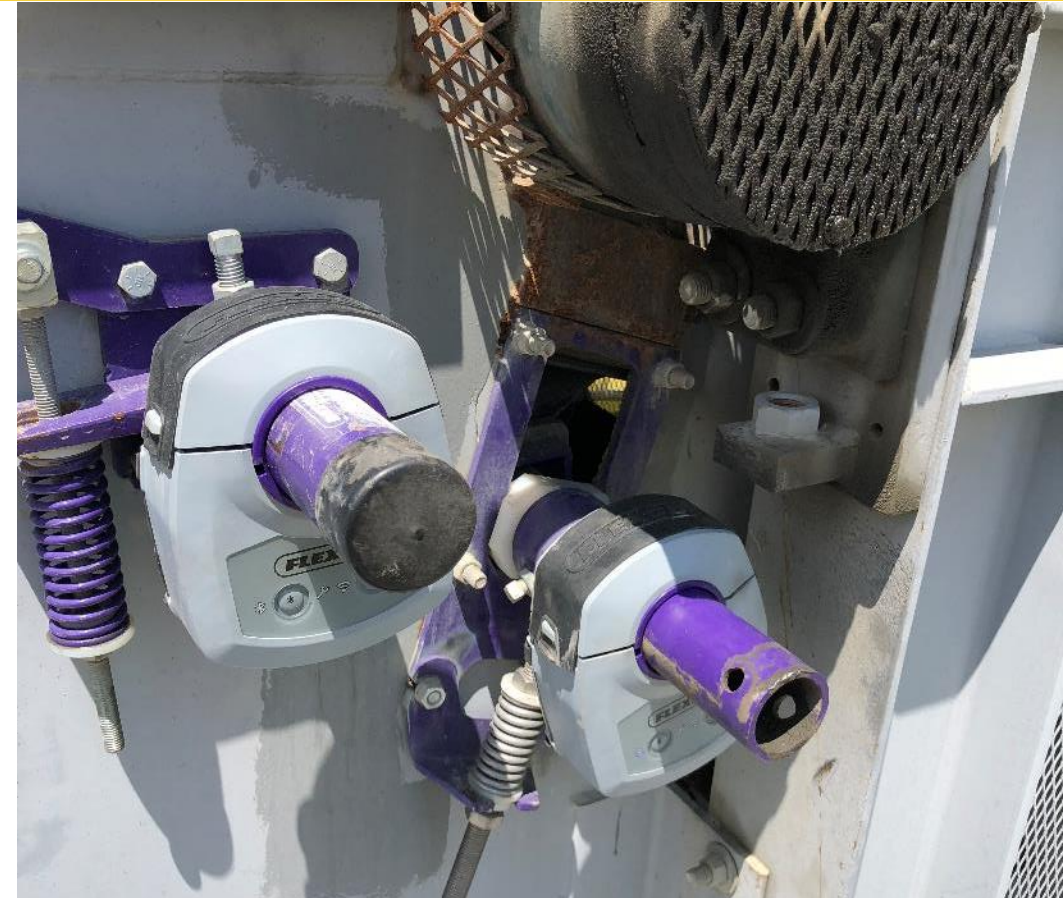
ON-SITE INVESTIGATION

The Y-type had been inaccurately installed causing uneven contact with the belt leading to uneven wear and poor cleaning performance. From first glance nothing looked wrong, but upon closer inspection based on the frequent alerts the issue was discovered.

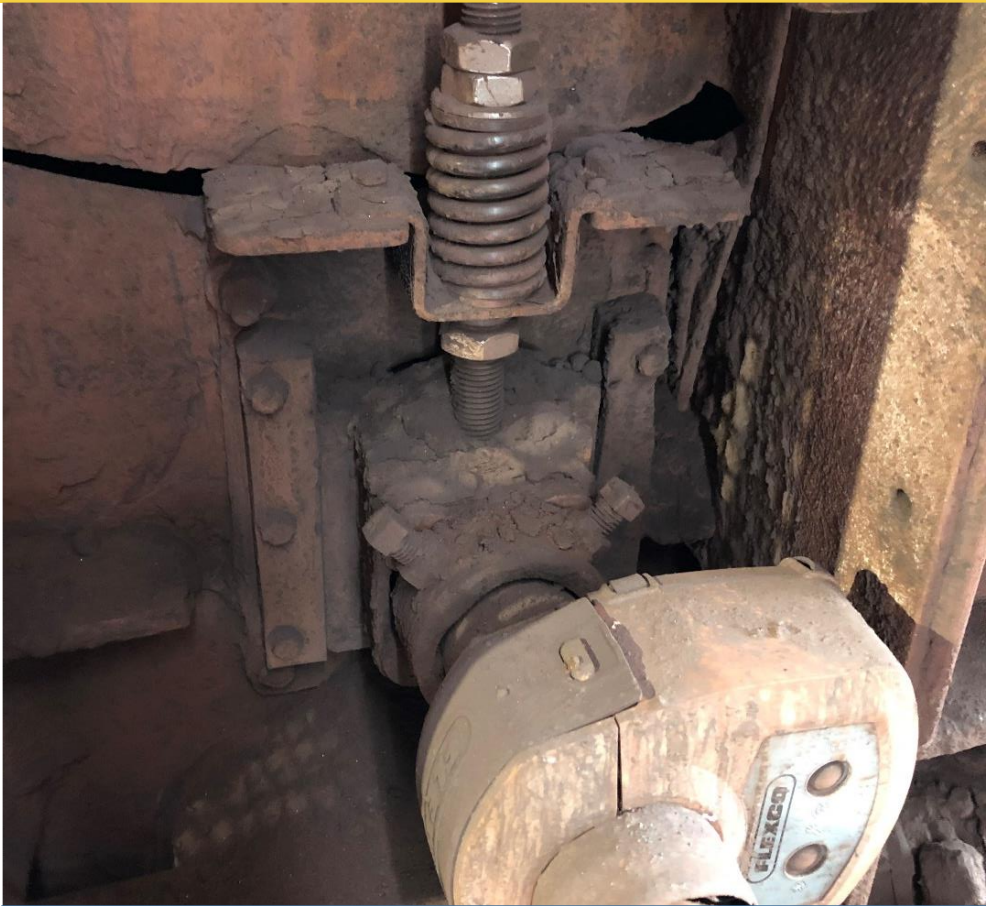
ON-SITE INVESTIGATION

Upon inspection, the crew found the MHS cleaner had seized from lack of maintenance, causing no relief points and transferring all the vibration through the pole versus being absorbed in the cushions and spring. The alerts drove the team to take action, increasing cleaning efficiencies and reducing risks across the site.

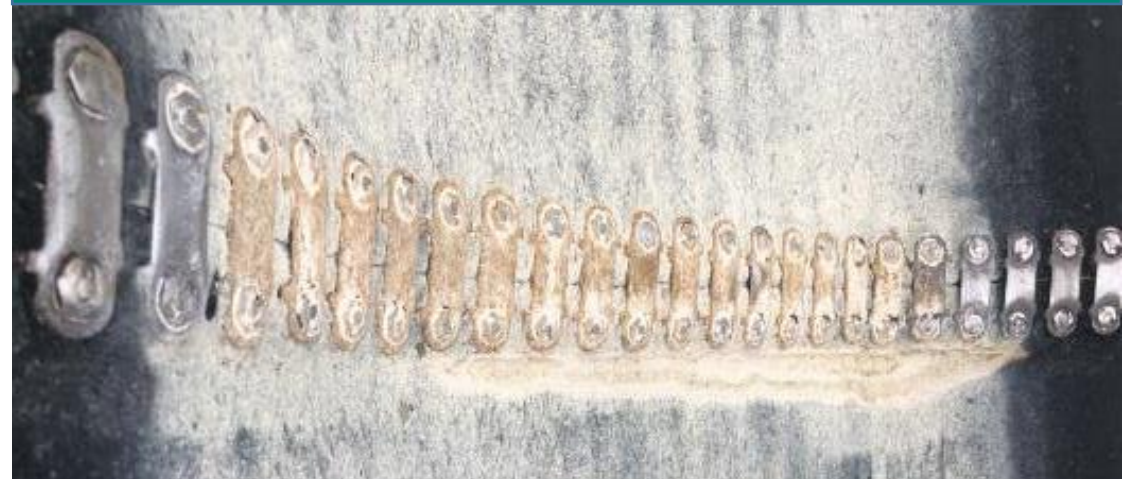
ON-SITE INVESTIGATION

The abnormal alerts were caused by an unskived fastener installation. While the splice posed no immediate threat, the cleaner was slowly wearing the belt down after the fasteners and it would have caused more damage if not addressed.

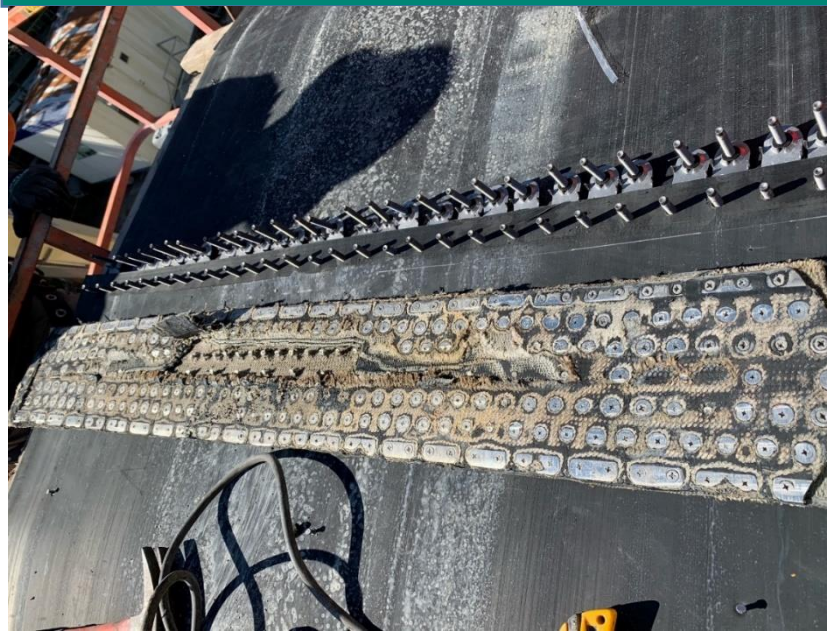
ON-SITE INVESTIGATION

The splice degradation was severe enough to nearly fail and warrant replacement. If undiscovered, the belt could have failed.

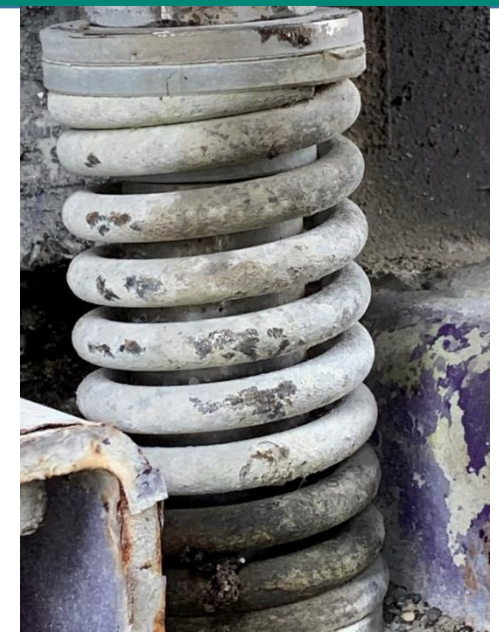
DIGITAL, PHYSICAL CONNECTION

Determining abnormalities in the running condition led to discovering failure in a predictive manner.

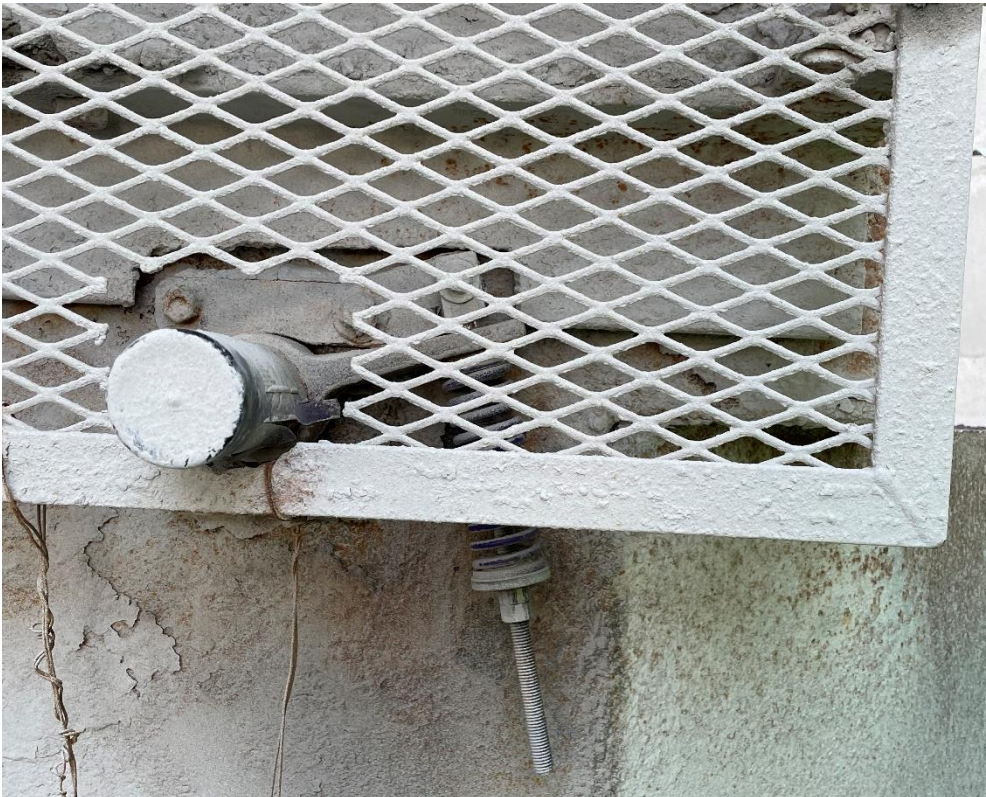
ON-SITE INVESTIGATION

Upon inspection, the crew found the EZP1 cleaner tensioning system had been set improperly, causing no relief points and transferred all the vibration through the pole due to no absorption from the spring. The spring arm was against the hard stop. The alerts drove the team to act and correct the issue on multiple cleaners, increasing cleaning efficiencies and reducing risks across the site.

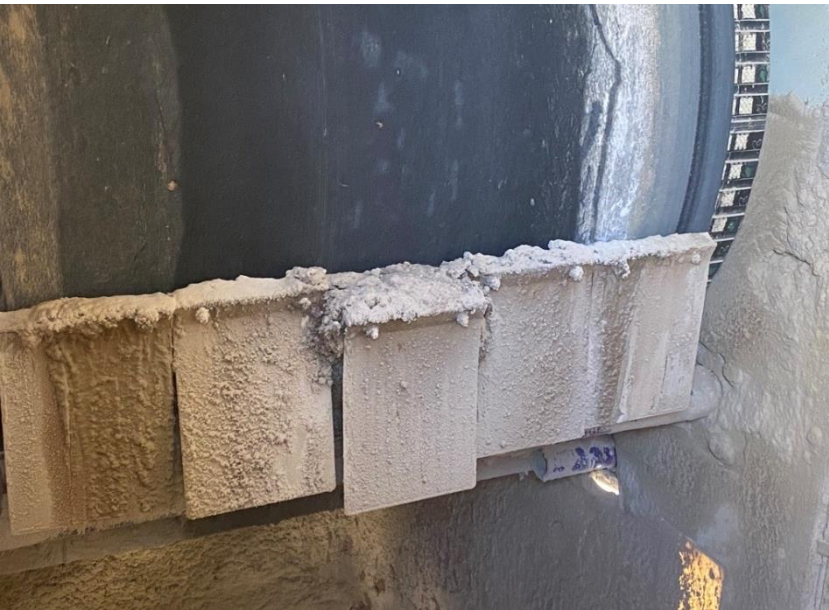
DIGITAL, PHYSICAL CONNECTION

Lack of segment relief with the rock/sticky material build-up eliminated system relief and caused high force transmissions.
